DEPARTMENT OF TRANSPORTATION

Contract #: 04-0120F4Cty: SF/ALA Rte: 80 PM: 13.2/13.9File #: 74.28**WELDING INSPECTION REPORT****Resident Engineer:**Siegenthaler, Peter**Address:** 333 Burma Road**City:** Oakland, CA 94607**Report No:** WIR-024064**Date Inspected:** 05-May-2011**Project Name:** SAS Superstructure**OSM Arrival Time:** 900**Prime Contractor:** American Bridge/Fluor Enterprises, a JV**OSM Departure Time:** 1745**Contractor:** Goodwin Steel, UK**Location:** Trentham, UK

WELDING INSPECTION REPORT

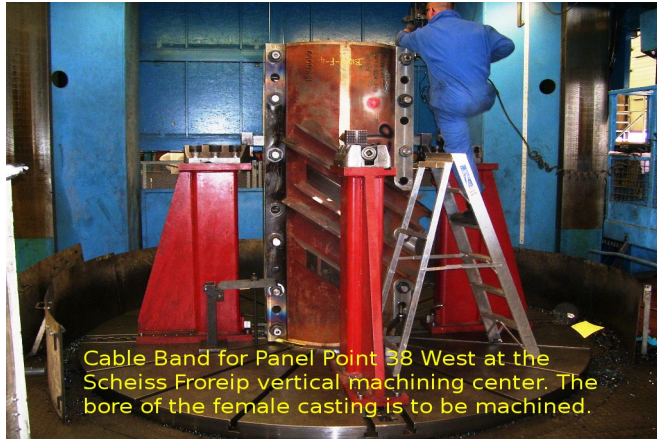
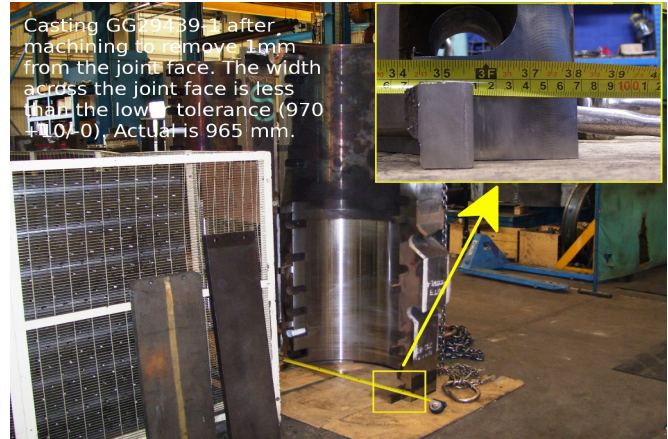
The QA inspector reviewed a copy of the Goodwin Steel Castings “Weld Excavation Map” for casting GG29439-1(R4), B10-1-F. The Weld Excavation Map was reviewed for accuracy and compliance with contract documents. This fifth repair cycle is a minor repair and does not require post weld heat treatment. Caltrans Lot Number B243-119-11 was assigned for tracking purposes.
